The Feversham Monument  
The Market Place  
Helmsley  
**Investigative survey**

By Peter Pace Architect and Ebor Stone CompanyLtd.  
on behalf of Helmsley Town Council

**24th February 2016**

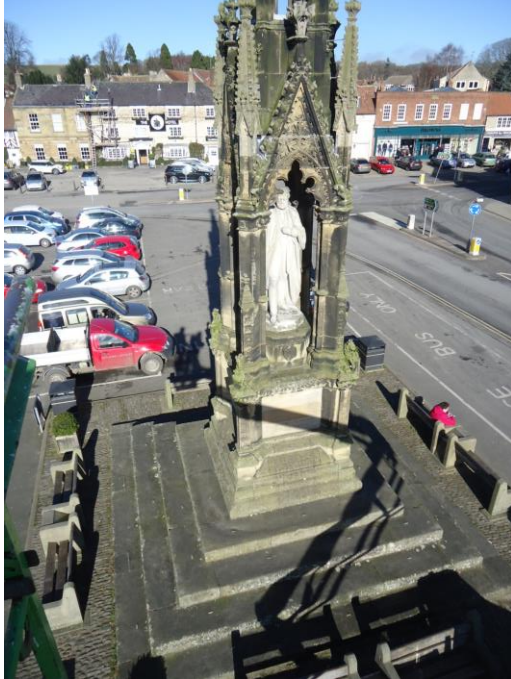
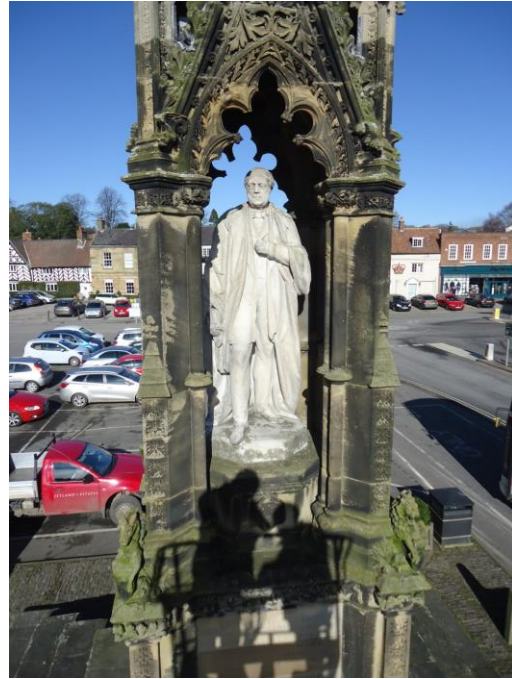
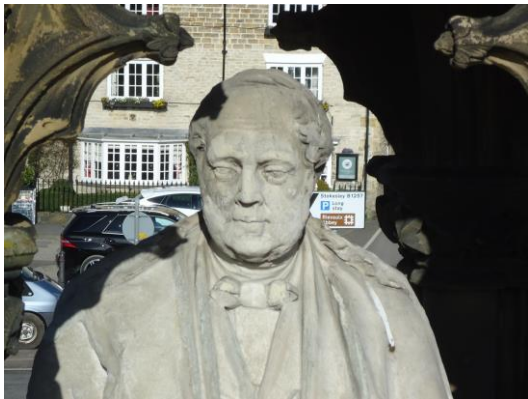
Base Area –

The stone work has been well repaired with small areas containing inserts which are firmly fixed, as well as larger pieces such as pinnacle which are also well secured, using a mixture of bronze and stainless steel ties.

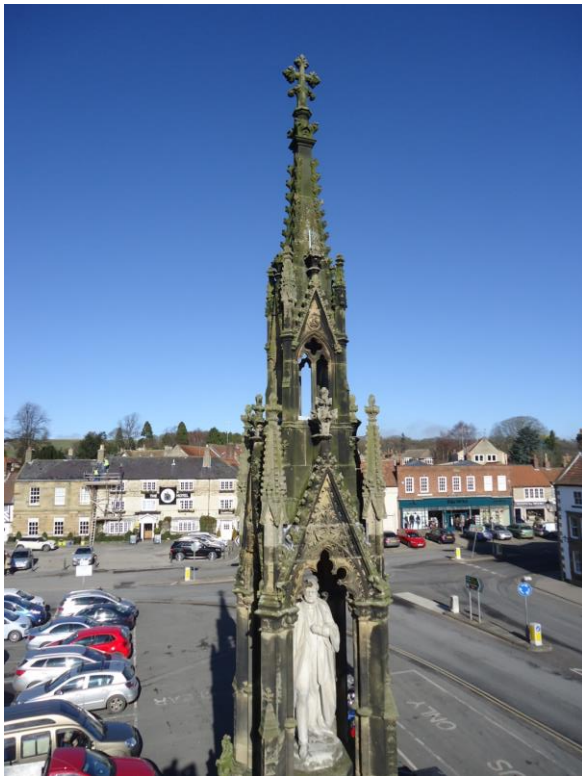
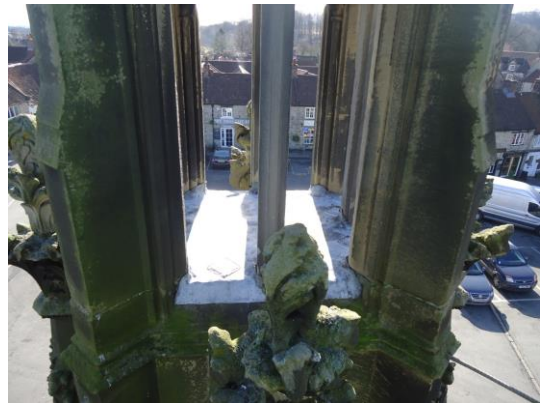
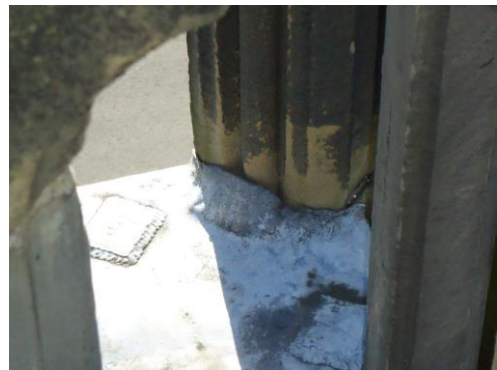
Middle Area –

The canopy has a lead lined base. This is sound, though at the edges the junction with the stonework is not tight. Redressing the lead will help and the application of Fosroc lead mastic seal is advised.

Lead to base of niche to be redressed and sealed

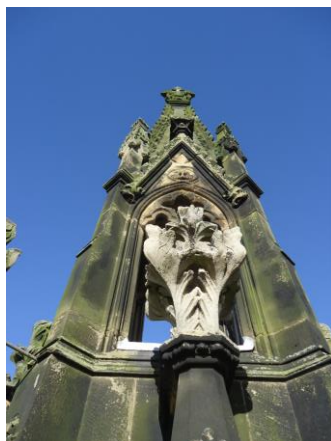
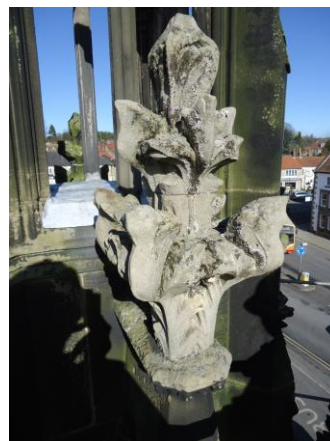
The top finial on the south side twists on its dowel and requires wedging and pointing to secure.

Lower section Finial to be secured

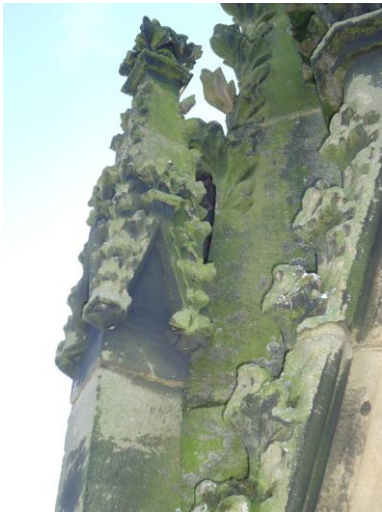
*North east*

The top of the pinnacles to the north and south sides are also twisting on their dowels and need to be similarly re secured.

Middle stage pinnacle tops to be resecured
