**THE FEVERSHAM MEMORIAL
and THE WAR MEMORIAL**

**CONDITION REPORT
with
RISK ASSESSMENT**

HELMSLEY TOWN COUNCIL

JUNE 2015

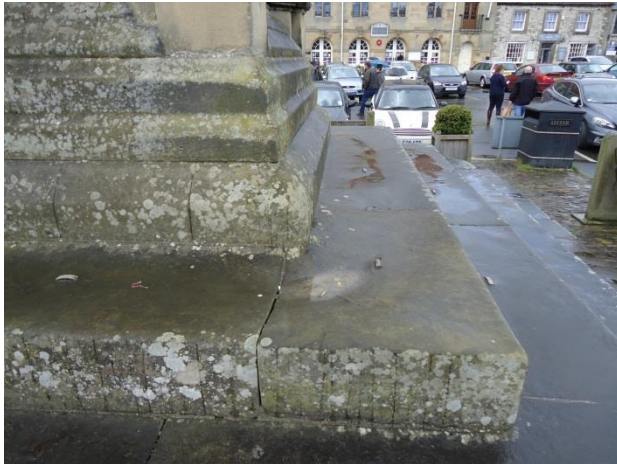
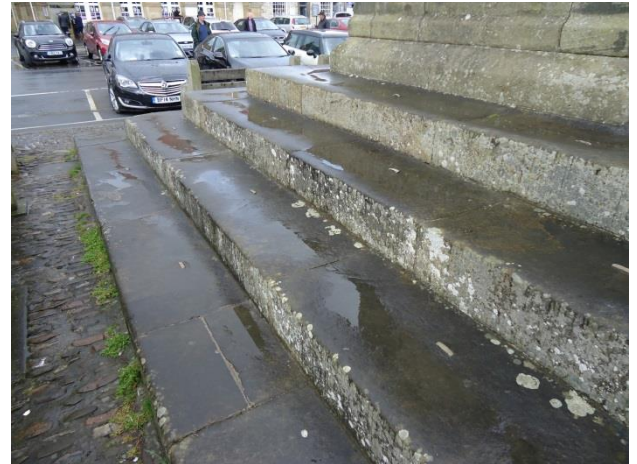
a) **The base** - This is constructed as a series of steps in very large pieces of solid sandstone. The steps have been lowered into position using a Lewis self-gripping tool, and the mortice holes used to insert the Lewis have been filled with very hard cement.

The sandstone steps have worn considerably from excessive wear from persons climbing the steps. They are also much used as a form of seating. The unevenness of the steps with the deep dished centre is not causing trouble as might be experienced where the steps were part of a staircase with foot traffic up and down. Here the movement of pedestrians is very limited with no opportunity to stumble down at speed, though of course anyone could lose their footing if not paying attention. The raised up mortice fillings are a possible trip hazard, but could be reduced by grinding down so they are flush with the top going of the step. Generally the steps are of sufficient weight and size as to be stable. A few open joints should be repointed to help reduce water penetration, and reduce the risk of frost damage in winter months.

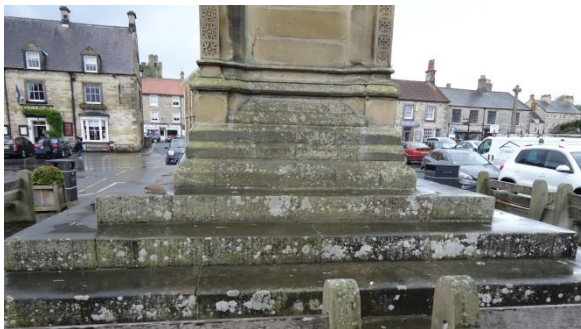
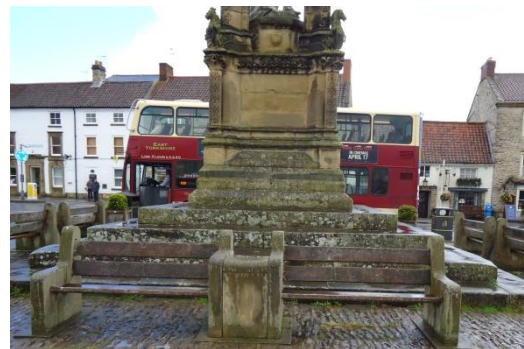
The lower part is formed as a series of stepped blocks with angled edges, making them difficult but not impossible to climb

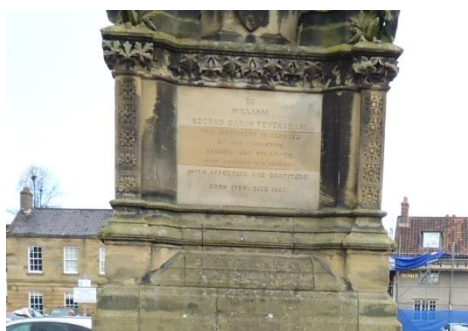
The top section contains a flat panel of stonework, which on the South side contains an inscription

The centre of the inscription has been renewed in the last 30 years, and all appears to be firmly fixed.

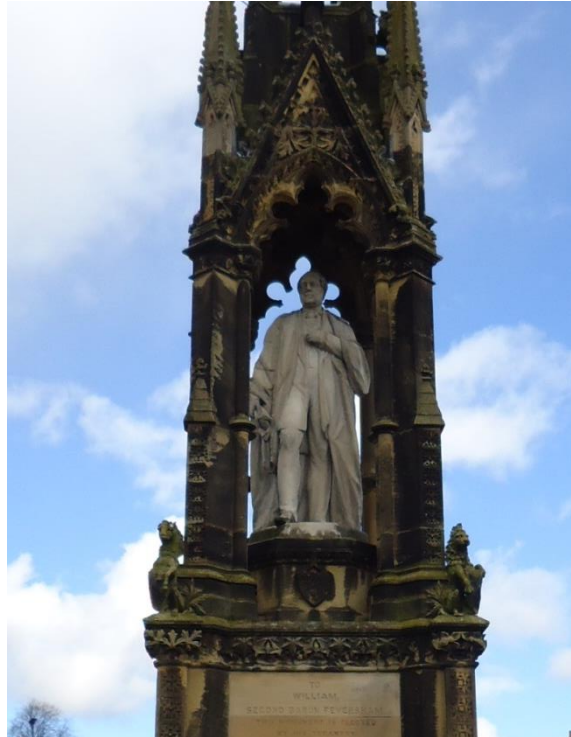
This part of the structure is really formed by four large corner buttresses. They show no signs of outward thrust, as the canopy above is formed of large pieces of stone, which are most likely tied together across the joints with metal cramps.

The stone work is dirty, due to past industrial pollution carried from the west riding and deposited on the stone by the rain. Sandstone allows pollutants to stick to its surface where exposed, but beneath sheltered overhanging parts where the rain does not reach, the stone remains unstained, thus producing a patchwork of staining.

The limestone statue is different, in that not only is it sheltered, but limestone reacts differently to rain. Dirt is not able to adhere so easily to limestone as the rain dissolves the limestone making it self-cleaning, except – in opposite to sandstone – where sheltered and not washed by the rain, deposit can accumulate. Fortunately in this case the statue is relatively clean.

The dirt on the sandstone will include sulphurous deposits which over a long period will cause deterioration to the sandstone. At present the effects are slight, and with the Clean Air Act further industrial deposits are unlikely to accumulate as they have in the past. Ideally some cleaning could be carried out to return the architectural composition without the distraction of staining, but the priority is not high from a technical view point- although aesthetically there is much to recommend it.

For the present the dirt is not affecting the structural integrity of the monument, nor does there appear to be any loss of the detailed carvings, where in some instances of chemical erosion small pieces can drop off causing a hazard to persons below.

A closer survey by a Stone conservator is required to confirm the position.

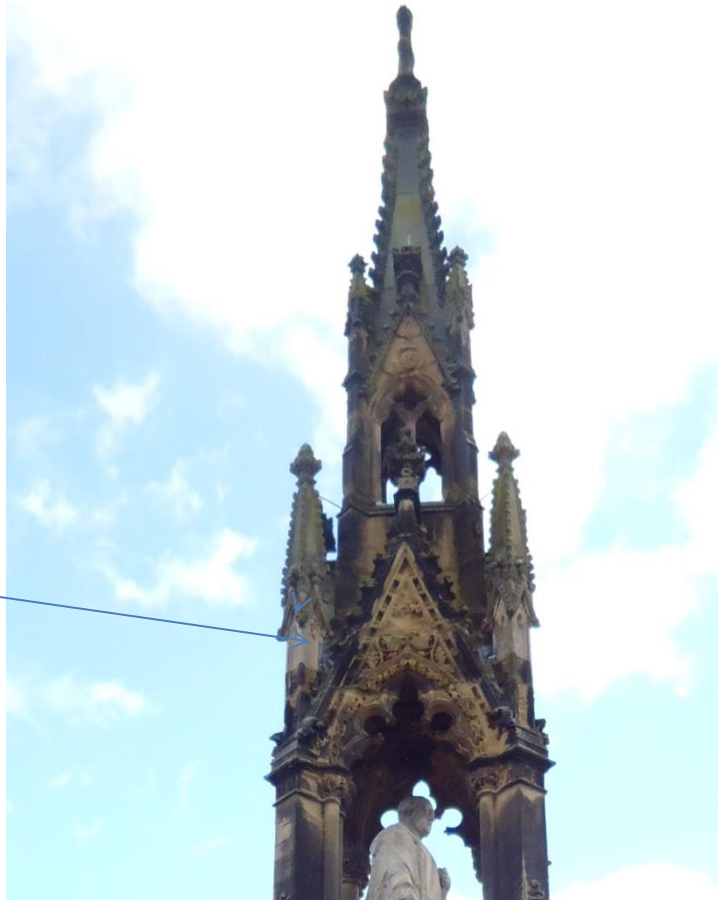
Finial renewed

The new pieces of stone are distinguishably as they are much cleaner!

Whilst it is reasonable to assume this major repair programme dealt with the problems at the time, it must be stressed in 30 years further deterioration may have occurred. Whilst there are no visual signs of fractures it is possible some joints may have weakened.

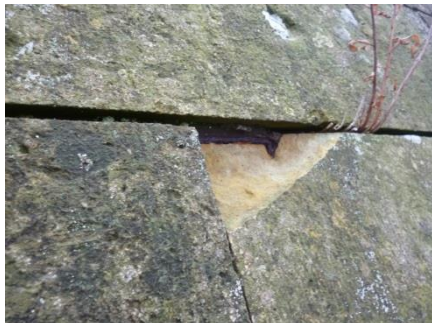
In Victorian times the most common form of strengthening stone work was to embed ferrous metal cramps which will rust and expand over the years and are responsible for much damage to ancient stone work. Below is an example from an 18th Cent Monument at Castle Howard :

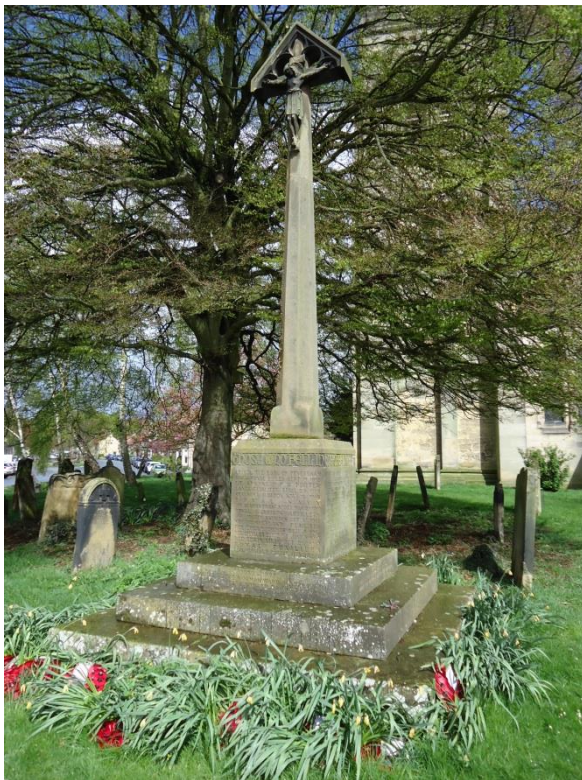
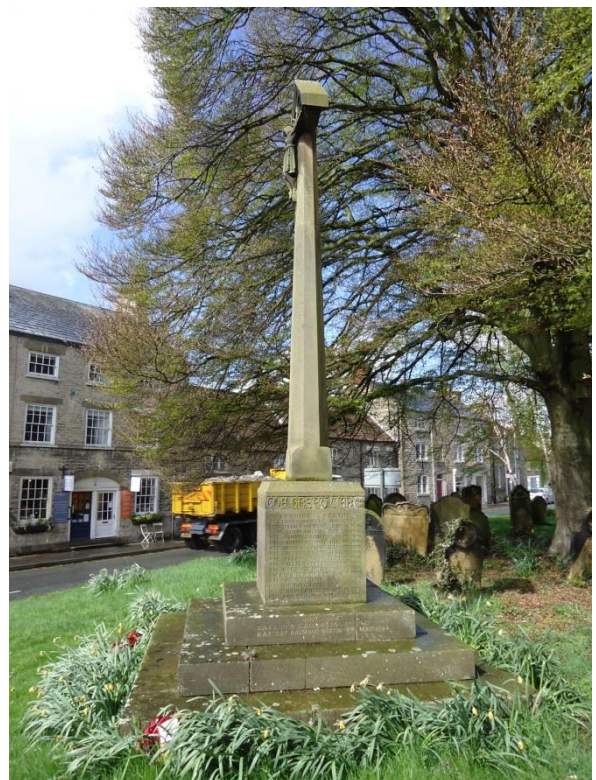
The memorial is constructed of Sandstone, and formed from large blocks of stone. It has been well constructed with no sign of subsidence, which can be common in grave yards where generations of burials have taken place. It is also near a high retaining wall and trees are close by, all factors which can lead to disturbance of the footings.

The cross shaft is very tall, and it is likely this will be morticed into the base block rather than secured with metal. The apex canopy and the crucifix figure are on the other hand probably secured with metal dowels, but at this date the metal used may well have been phosphor bronze, as the problems with ferrous metal were well known at

this time. In that case the likelihood of expansion and fracturing of the stonework is extremely low, and there are no signs of such stress fractures.
Generally the memorial looks to be in excellent condition. However without a close look at the apex from a hydraulic platform, it is not possible to be absolutely certain.
In term of safety/ unauthorised access, this is a difficult memorial to climb, although not impossible.

Summary – The memorial is in good condition. As an important listed structure, any alterations would be difficult to carry out as Listed Building Consent would be needed and, without a very substantial case for giving the monument protection, this is unlikely to be granted.
